Supplemental Service Manual

906-2150-002 Rev. C, TEXT ONLY

***Centurion** Vision System Supplemental Service Manual**

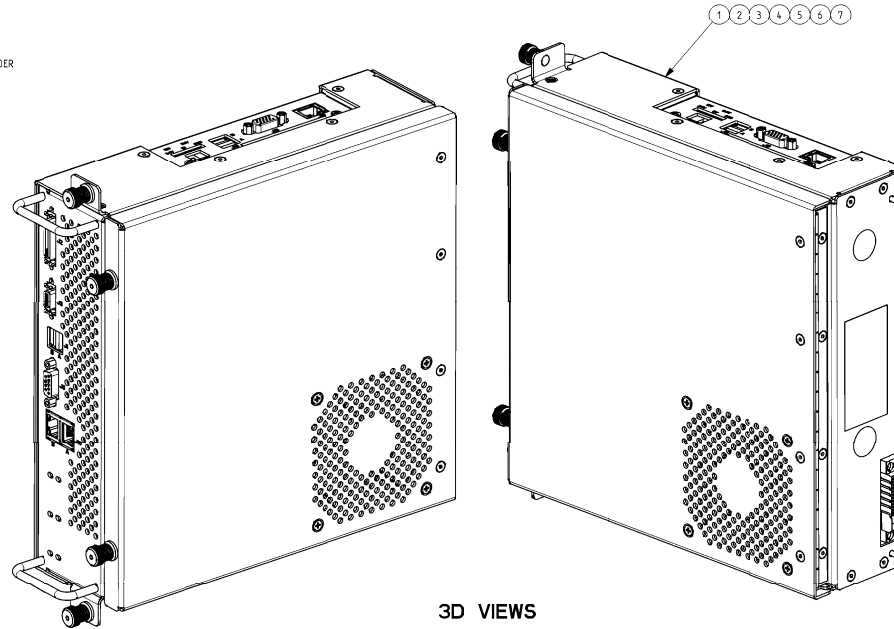
3D VIEWS

QTY	PART NUMBER	DESCRIPTION	MATERIAL/MANUFACTURER	ITEM
BILL OF MATERIAL				
REV	J. MCGUIRE	DATE	9/21/10	
REVISION	M. ESCALANTE	DATE	9/23/10	
APPROVED	A. SAH	DATE	9/23/10	
DATE	2/23/2007			
PDM LINK MODEL ATTRIBUTES	NAME: 215-1008-002			
		DESCRIPTION HOST ASSY. ADVANTECH		
		SIZE	D	CRASH FILE NUMBER
		SCALE	4:5	215-1008-002
		SHEET	1 OF 6	REV C
		VERSION	C.1

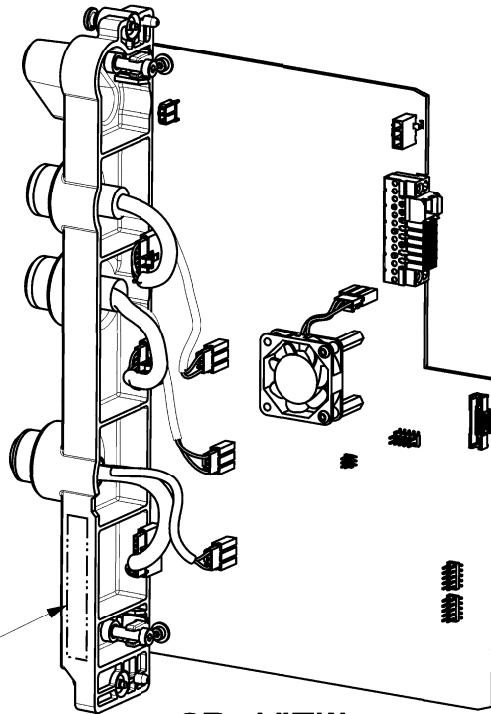
3D VIEW

5. 215-1009-501S IS MADE FROM ONE 215-1009-501.

6. -501S: TEST PER MTP 907-2150-022, FIELD SERVICE TEST MATRIX.
